## **FLINDERS PIER**

# **A REPORT ON THE FAILURE TO MAINTAIN THE PIER TO ENSURE ITS PRESERVATION**

**Prepared by**  
**Flinders Community Association**

**December 2021**

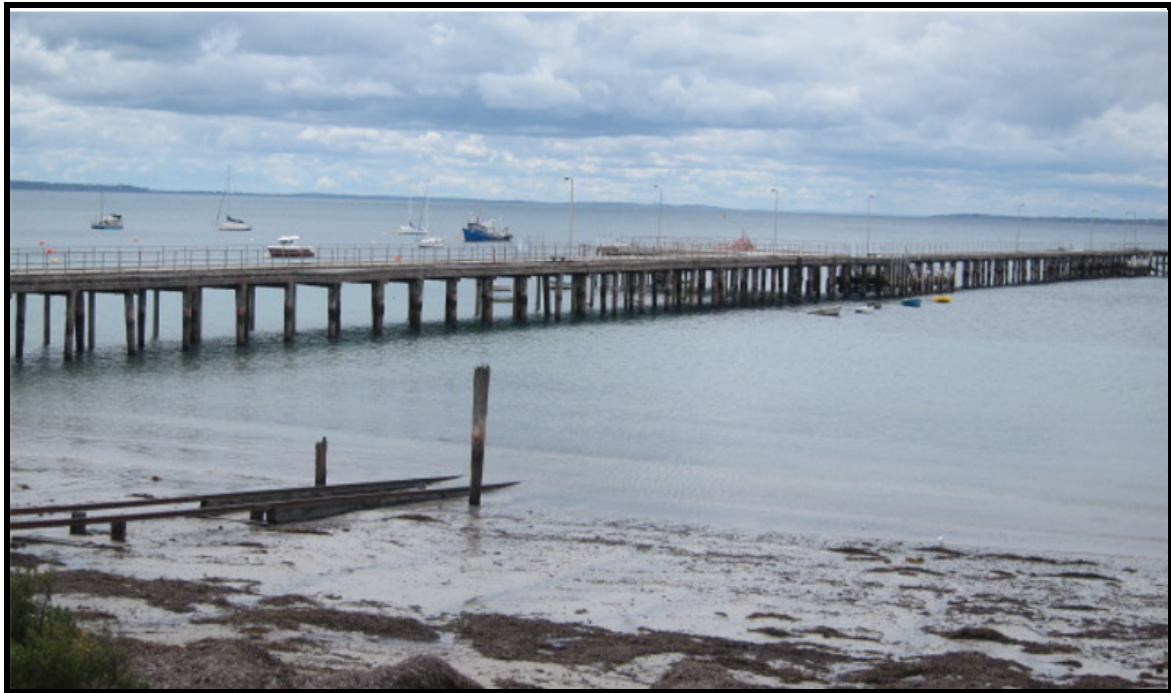
**Image 1:** The south side of the pier.

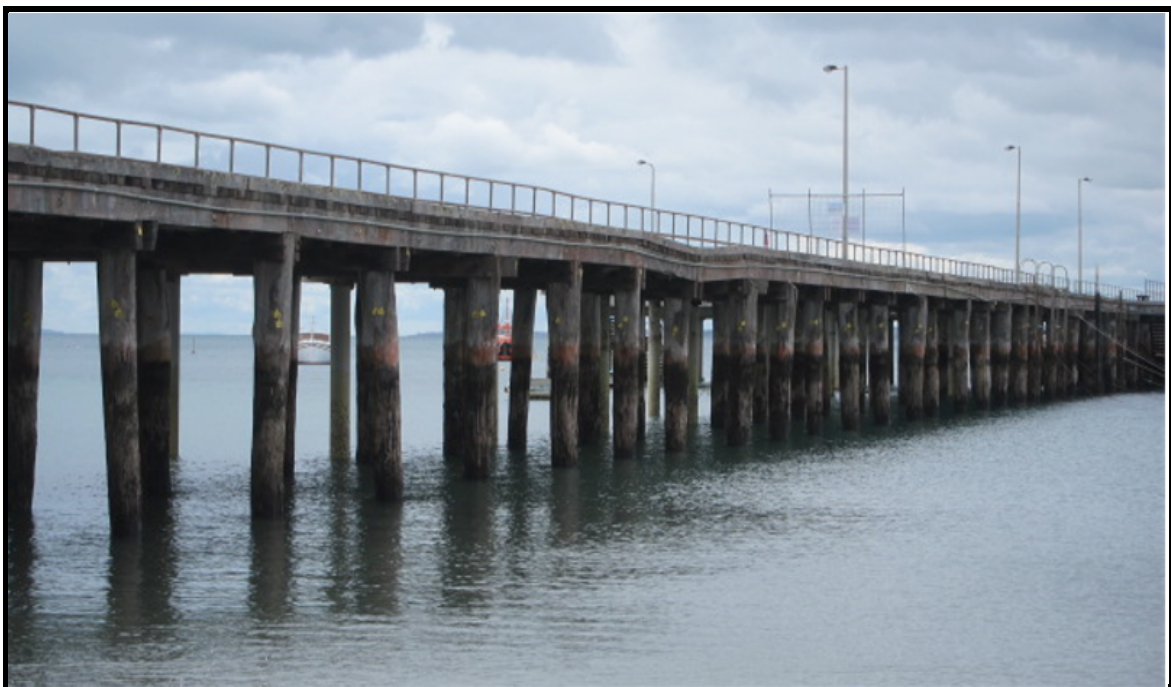
To the casual observer, the pier currently appears sound along its entire length apart from a dip in the deck in the inner section in the vicinity of Pile 22B.

**Image 2:** Partially collapsed inner section

The dip in the deck is located at Pile 22B the location of which is shown in red on the SKM drawing.

It is SFP's opinion that the collapse of the deck (in part) attributed to Pile 22B could be repaired by insertion of a steel pile behind the faulty pile. This could have been done as part of regular maintenance.

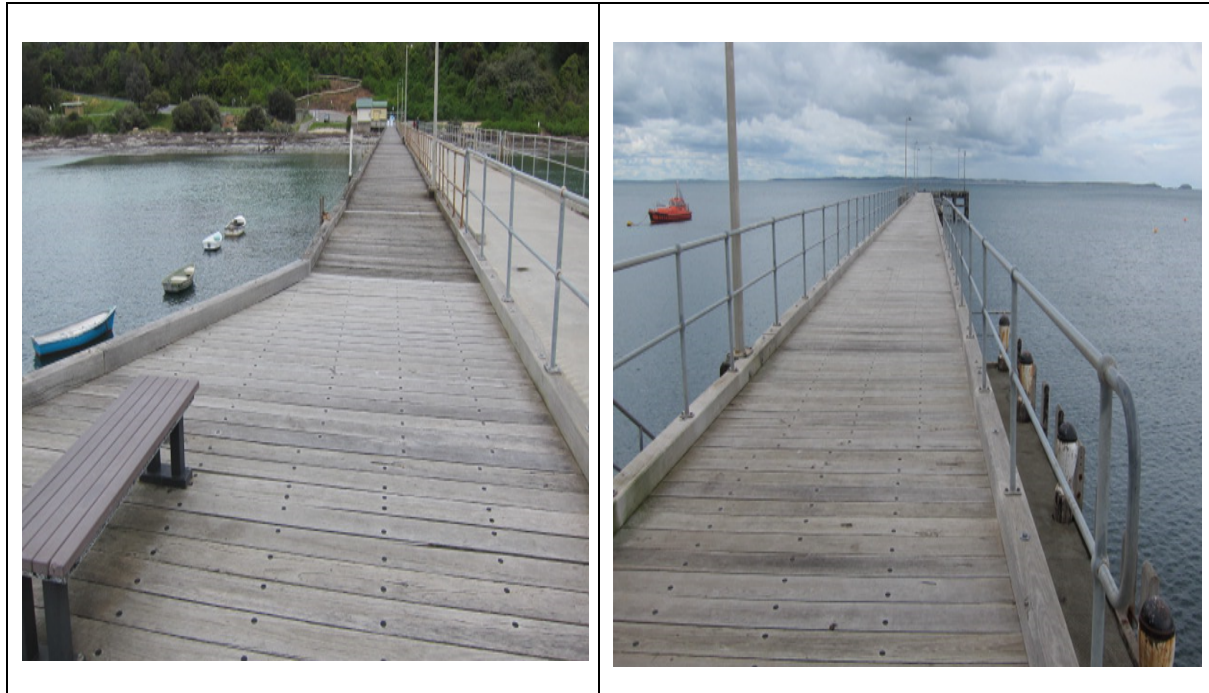
**Images 5 and 6:** Outer deck. Note new decking but piles remain 'as they were'.

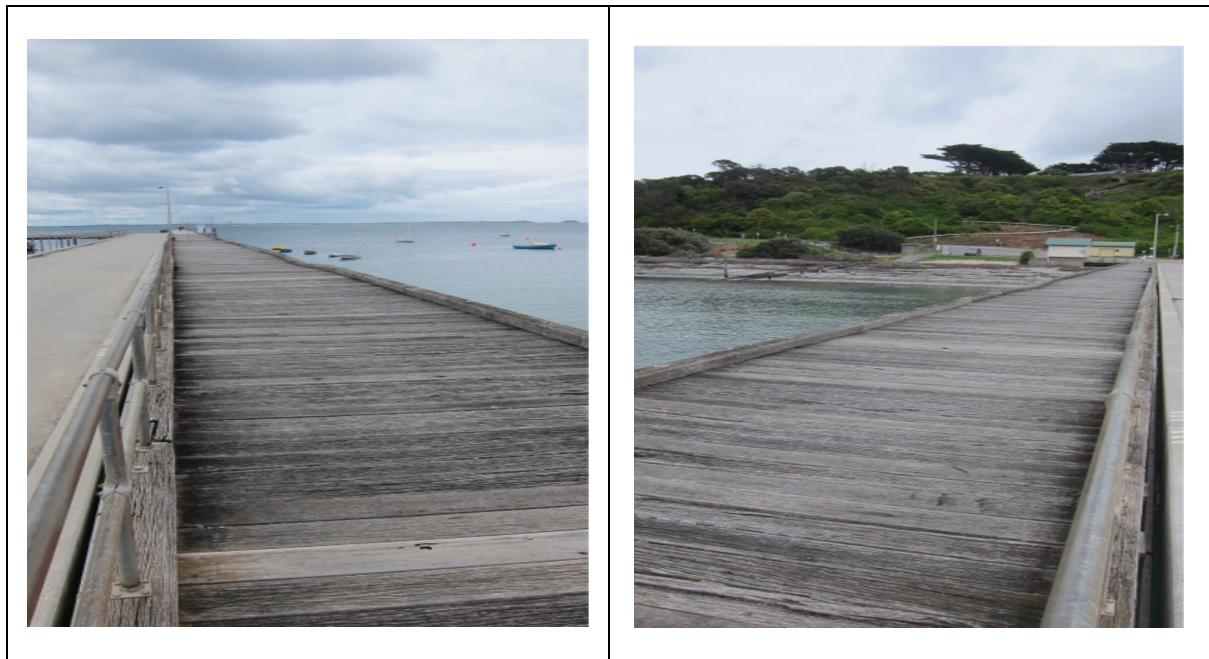
**Images 3 and 4:** Inner section deck

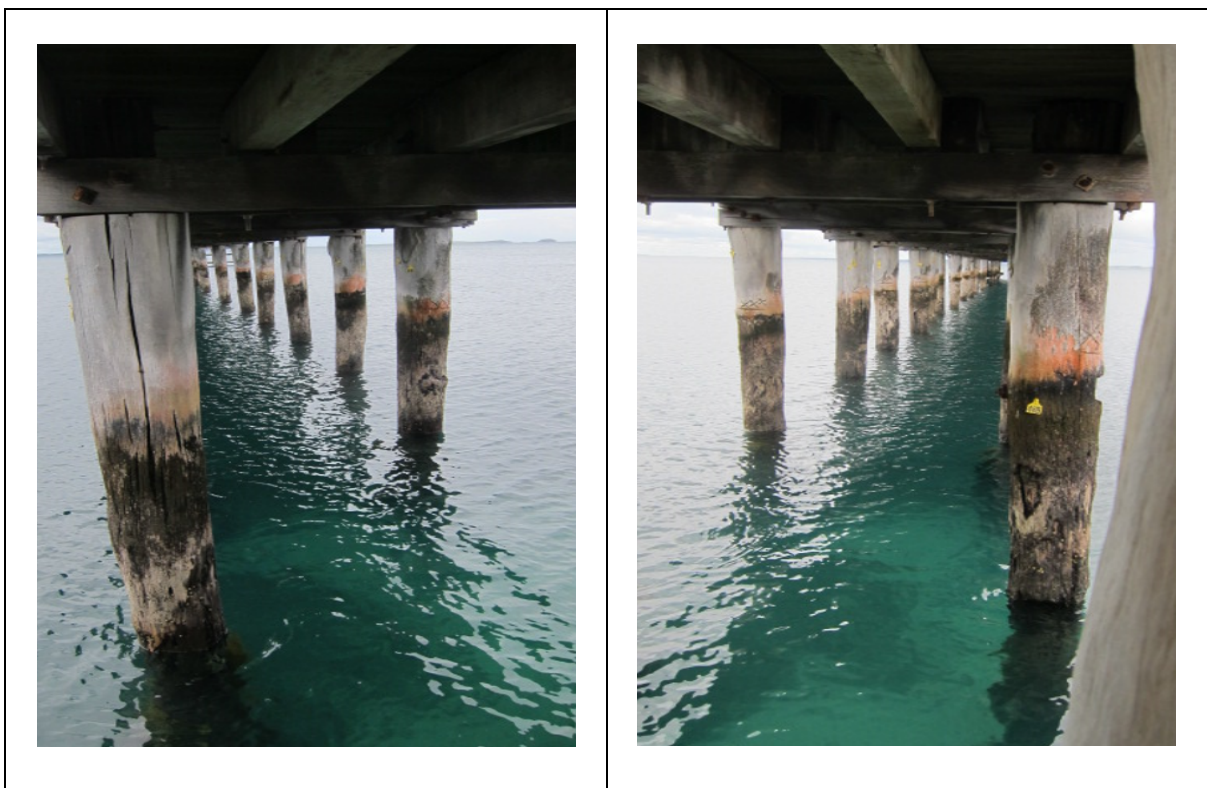
There were five outer section piles recommended for similar treatment, but this does not relate to any decision taken with respect to the inner section.

**Images 7 & 8:** Outer section piles.

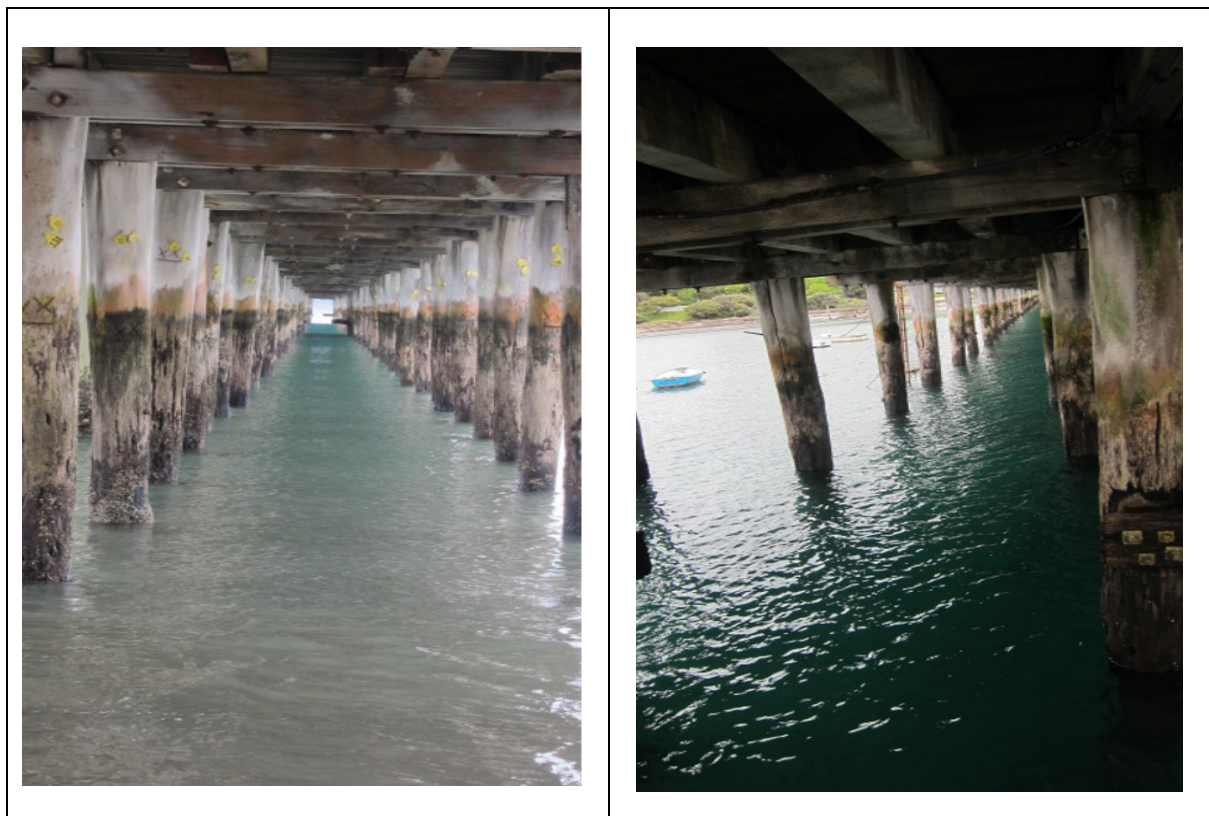
**Image 9 & 10:** Inner section piles

It is apparent from the KINA Report and the attached imagery that inner section piles are in no worse condition than the outer section piles. Whilst a new 'deck' has been installed on the outer section, the inner section has been allowed to fall into disrepair and the KINA recommended maintenance and repair for the inner section has not been undertaken by Parks Victoria despite having known of the need for works since 2016.

Piles 4B, 7B, 11A, 28B – are described as in poor condition. Recommended repairs – splint, repair/epoxy. Pile 28 – epoxy encapsulation.

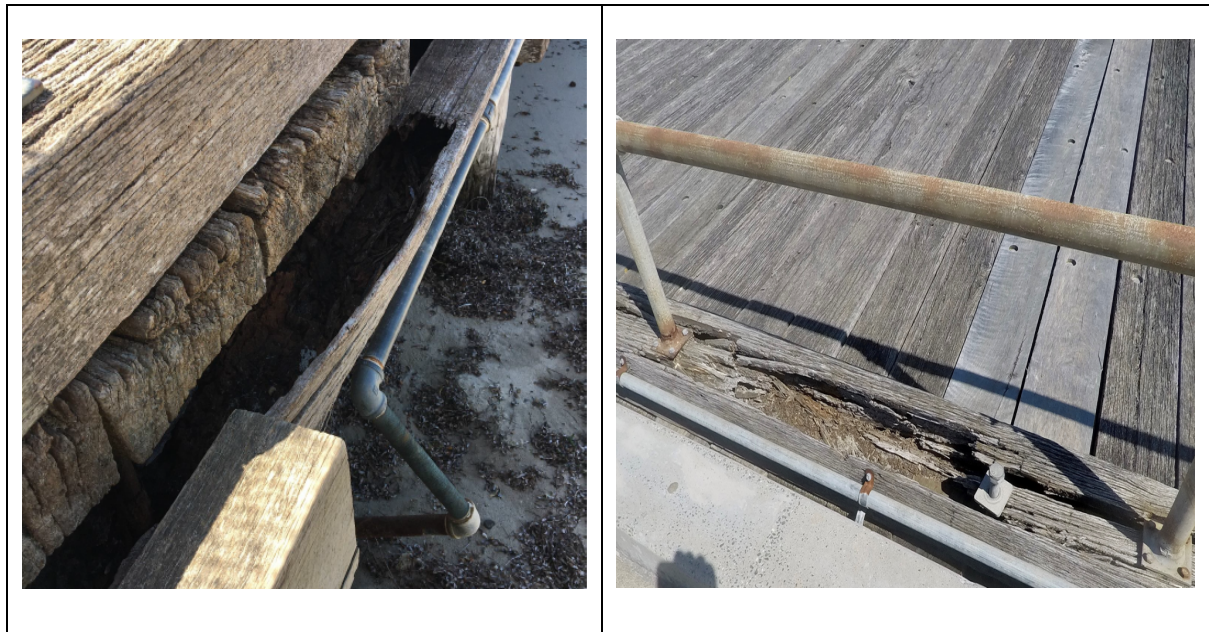
The following photographs depict sections of the inner section of the original pier which have deteriorated and have lacked any attention to maintenance.

**Images 11 & 12:** Deterioration due to lack of maintenance.

By any reasonable view of the status of the inner pier, it is only in worse condition than the outer section due to a lack of attention and maintenance.

Parks Victoria must undertake immediate works to again make the inner section of the Flinders Pier safe for pedestrian use; and ensure the ongoing structural integrity of the full pier (both inner and outer sections).

Furthermore, Parks Victoria must commit to reinstating a maintenance regime for the Flinders Pier to ensure that it never again falls into a state of disrepair that poses a risk to public safety.

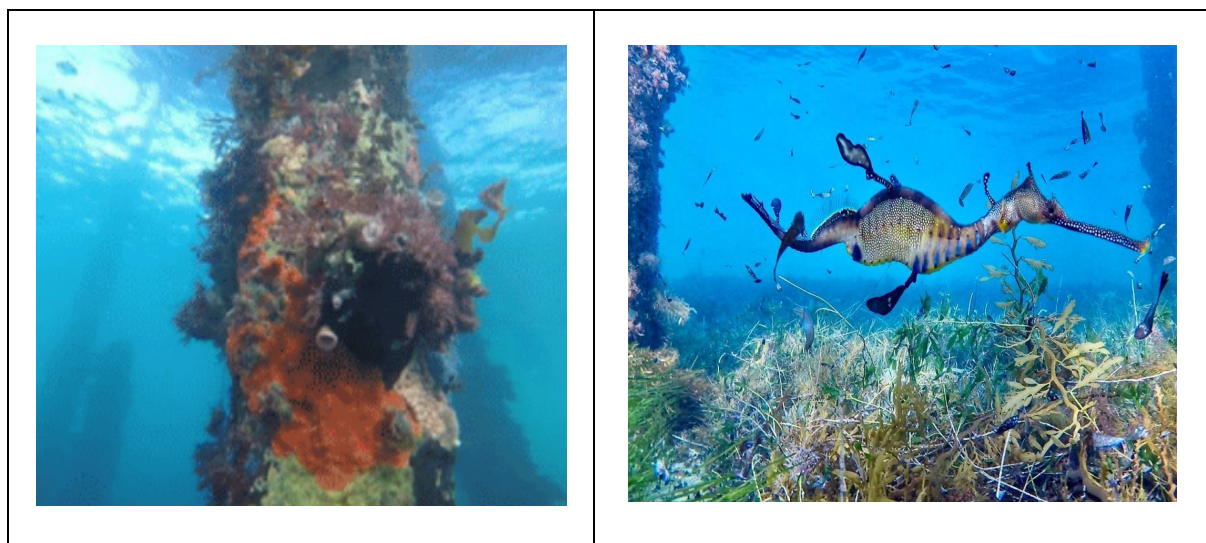
**Images 13 & 14:** Pile vegetation and Weedy Sea Dragon beneath the pier.
