Condition Assessment Report

Flinders Pier
Parks Victoria

Reference 210178
Revision 4
Date 4 May 2022

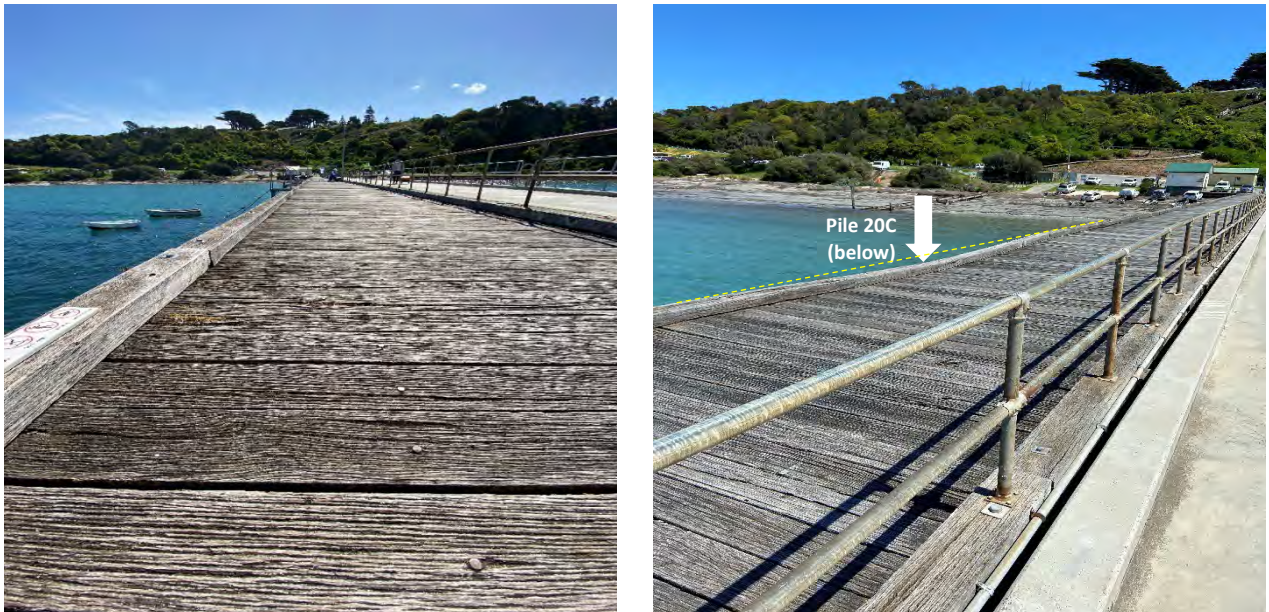
One pile - Pile 20C which is located within the 'Landside Section' of the jetty – was assessed as Condition Rating 7 indicating that the pile has failed and is no longer serviceable. Failure of this pile is identifiable due to a significant settlement of the deck over the pile and is believed to be one of the main reasons that pedestrian access was closed to this section. Figure 4-1 highlights this deflection in the deck in comparison to the remainder of the pier.

Figure 4-1: General overview of pier (left) and noticeable sag in deck at Bent 20 (right)

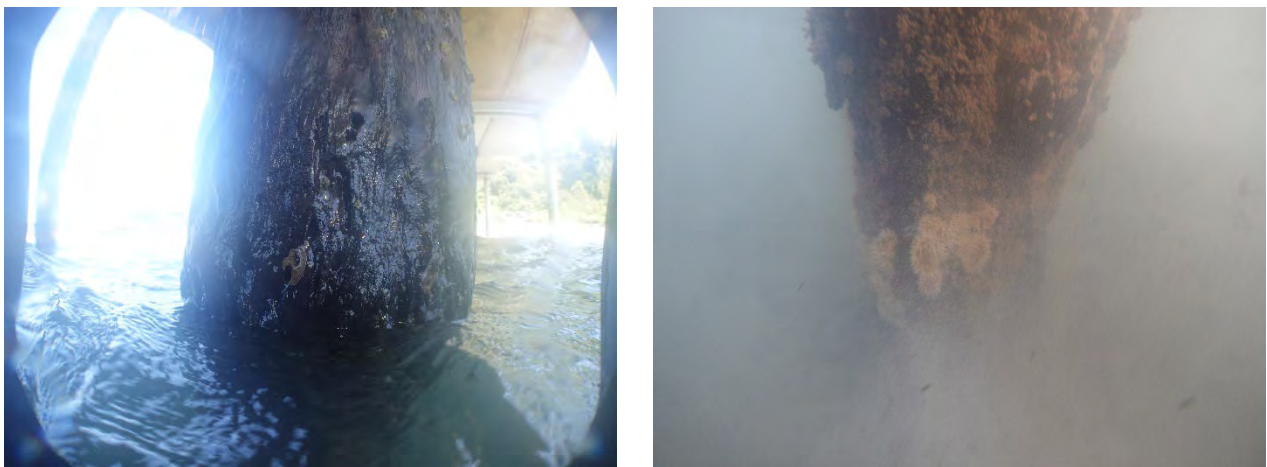
The dive inspection also found that Piles 16B, 19C, 20B, 21B and 22B (which are all in close proximity to 20C) were in poor condition (Condition Rating 6) based on depleted sections resulting for borer activity. This region also corresponds to the most severe area where marine borer activity was identified across the entire 325 metre length of the pier. Southern Divers noted that the borer activity was most severe at the seabed in this area and even extended below the mudline. Figure 4-2 highlights this comparison between borer depletion at water level and and at seabed level for Pile 20B.

Figure 4-2: Pile 20B at the water line (left) and at seabed level (right)

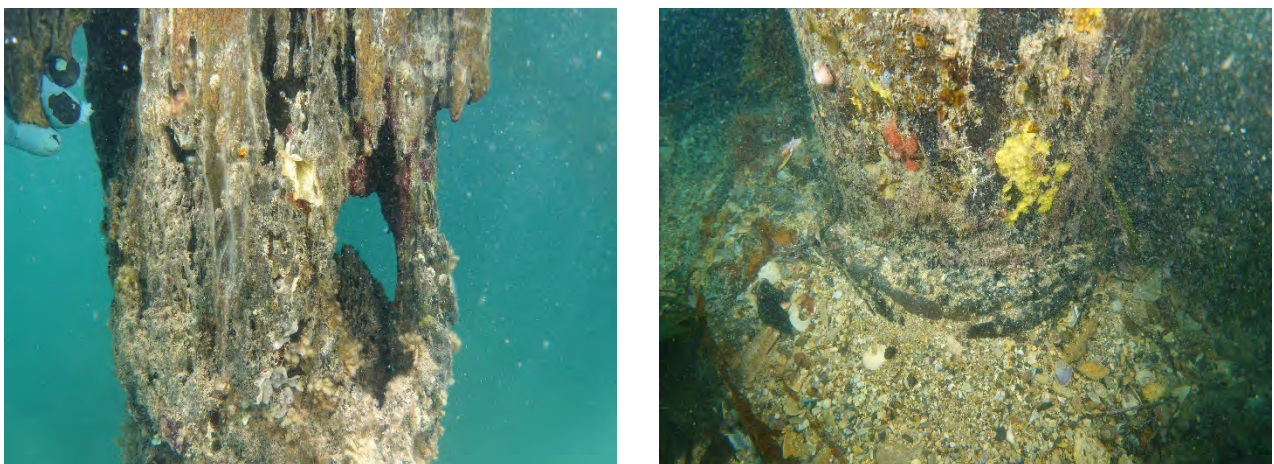
Figure 4-3: Localised cavity in Pile 44A (Condition 6 - left) and sound condition at seabed level (right)

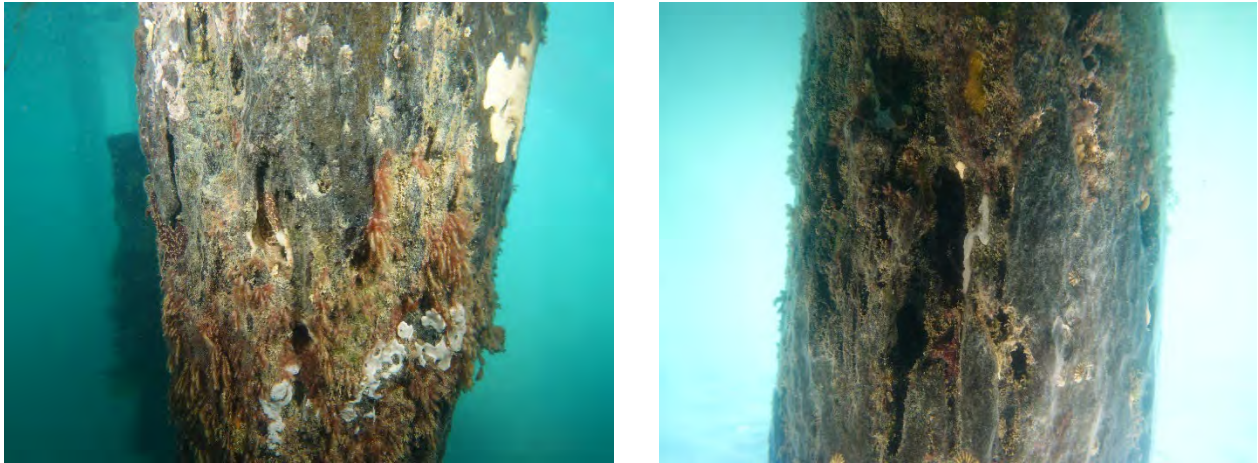
Generally, as the inspection continued along the length of the pier past Bent 22, the condition of the piles below water improved. Whilst some piles contained localised cavities (refer Figure 4-3) resulting in Condition Rating 6, piles without major defects were typically in excess of 300mm in diameter across the length of the piles and were categorised as fair condition (refer Figure 4-4).

Figure 4-4: Typical condition of fair piles (Condition 4)

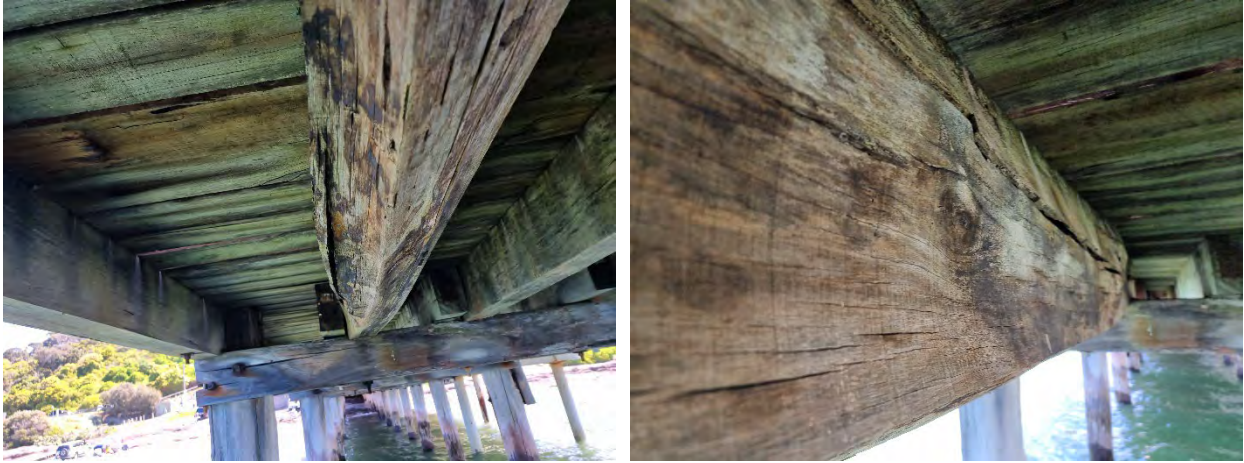
Figure 4-5 highlights examples of termite activity where the beams have bowed out laterally and lost all structural integrity. Figure 4-6 also demonstrates beams where heavy termite frass was identified and where the timber essentially disintegrated at the touch.

Figure 4-5: Hollowed out and crushed timber beams due to termite infestation

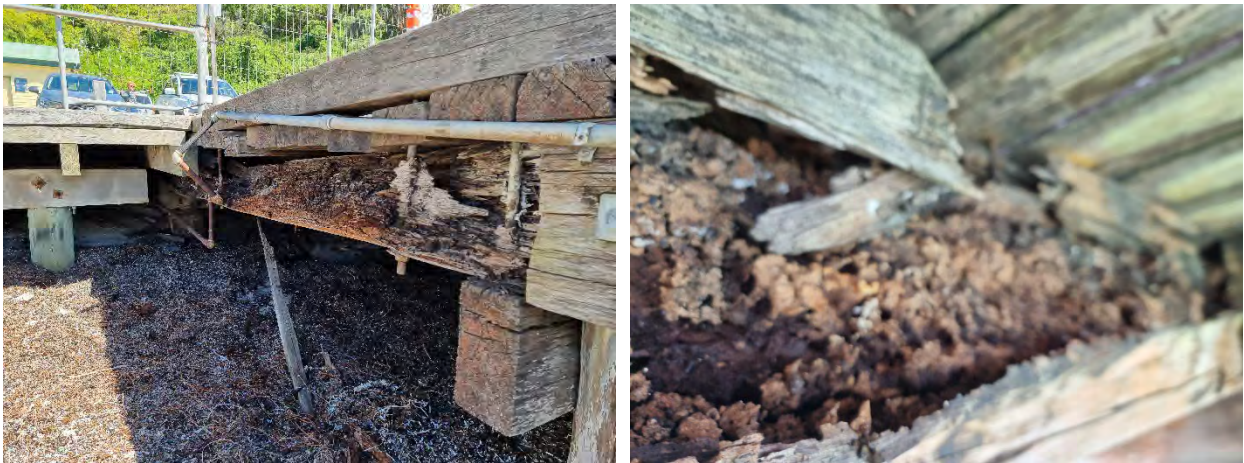
Figure 4-6: Beam 1E that has completely failed (left) and a close up view of termite attack (right)

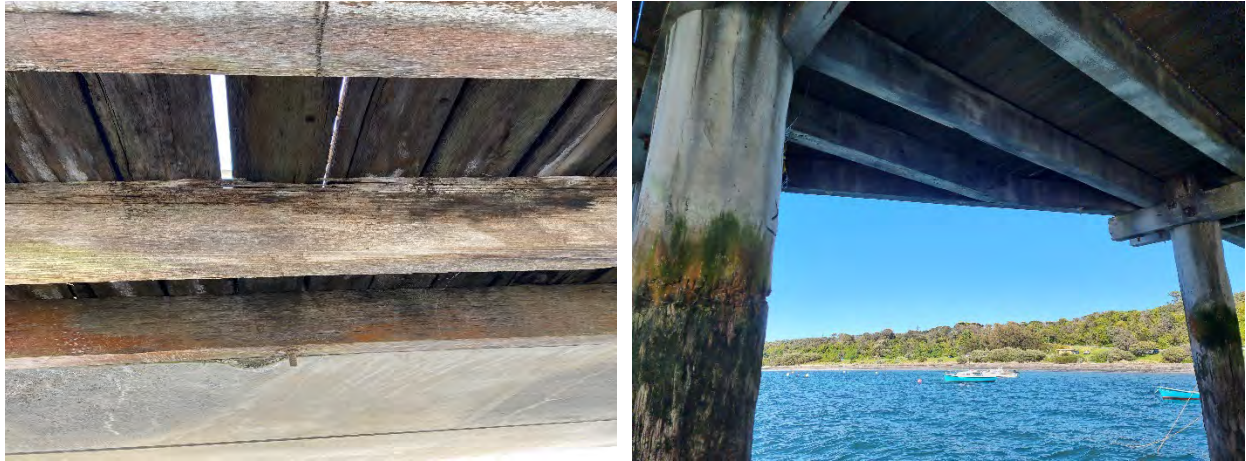
Another item to note is that at the Landside Section of the pier, the tops of the running beams were soft and beginning to deteriorate from rot. A typical mechanism of avoiding such degradation is through installing an impervious membrane atop the individual members to protect from the elements. Range engineers identified that this has been performed during the replacement of the Seaward Section timber members (refer Figure 4-7).

Figure 4-7: Top rot (left) and preventative membrane on newer members (right)

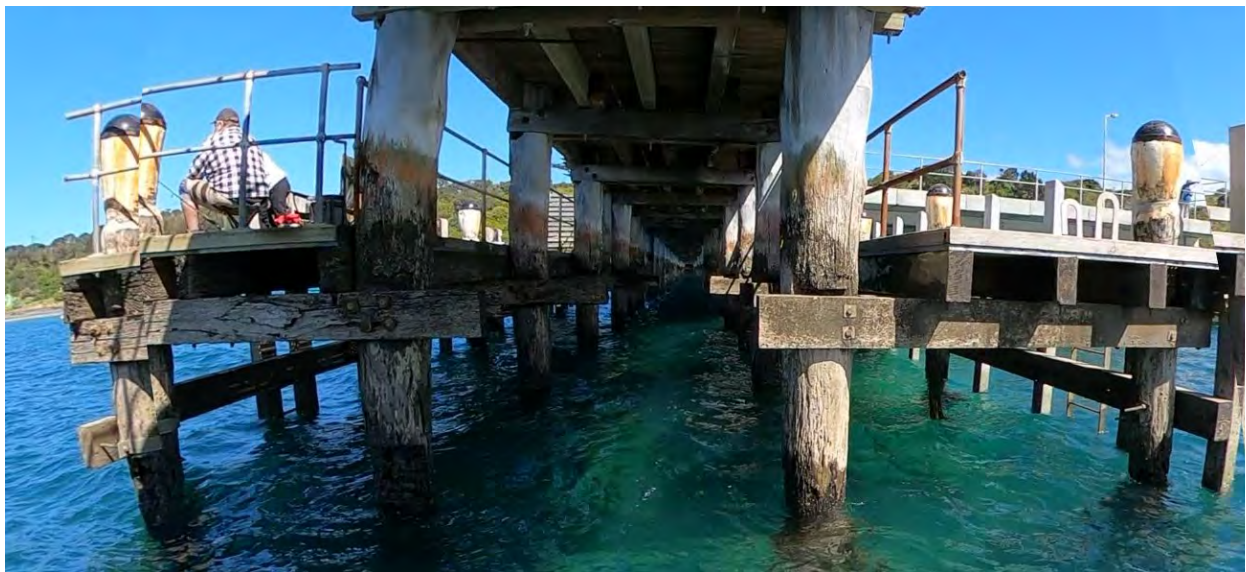
All lower landing beams were assessed as Condition Rating 4 despite constant wetting and drying from the tides and waves. Drummy testing indicated that despite the constant wetting of the timber, the condition beyond the damp outer surface was solid and sound timber. At the northern section of the central lower landing, the timber beams have been recently replaced with new timber (assessed as Condition Rating 2) and the difference in condition can be seen in Figure 4-8.

Figure 4-8: Older and newer central north lower landing members (crossheads)

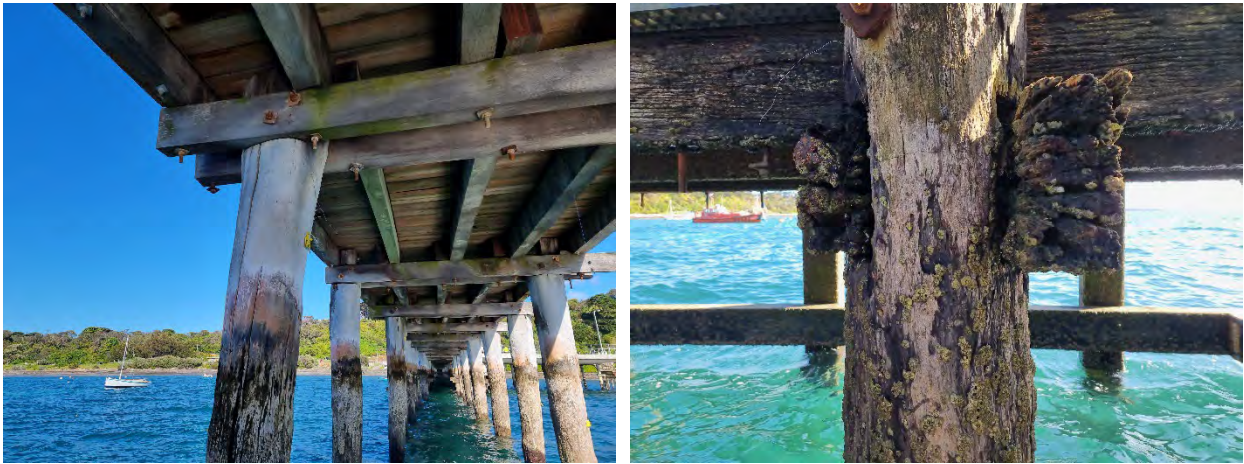
The majority of the timber crossheads were in fair condition with 95% of the members assessed as Condition Rating 3 or 4. Most of the crossheads were exhibiting splitting and checks at the ends of the member where they are more exposed to the elements; however, the splits had not propagated to the bolts connecting to the piles and hence were not affecting the structural integrity of the members. This is highlighted in Figure 4-9. Drummy testing only identified two crossheads that may be affected by

Figure 4-9: General condition of crossheads (left) and typical deterioration of member ends (right)

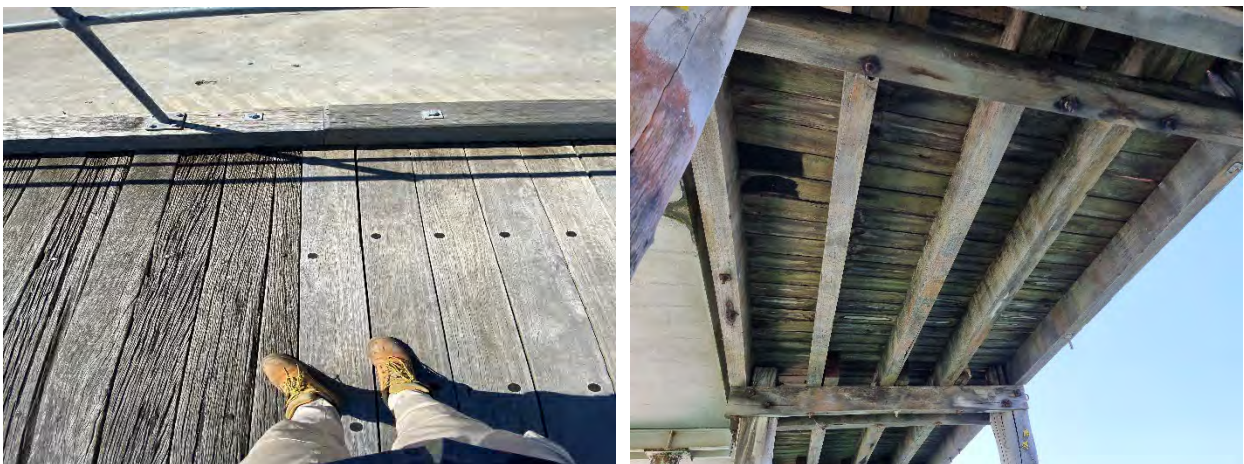
Figure 4-10: Comparison between new and older deck members (left) and localized fire damage (right)

Localised fire damage was observed to the underside of two members at Bent 30 as shown in Figure 4-10 although this area is now not accessible to the public.

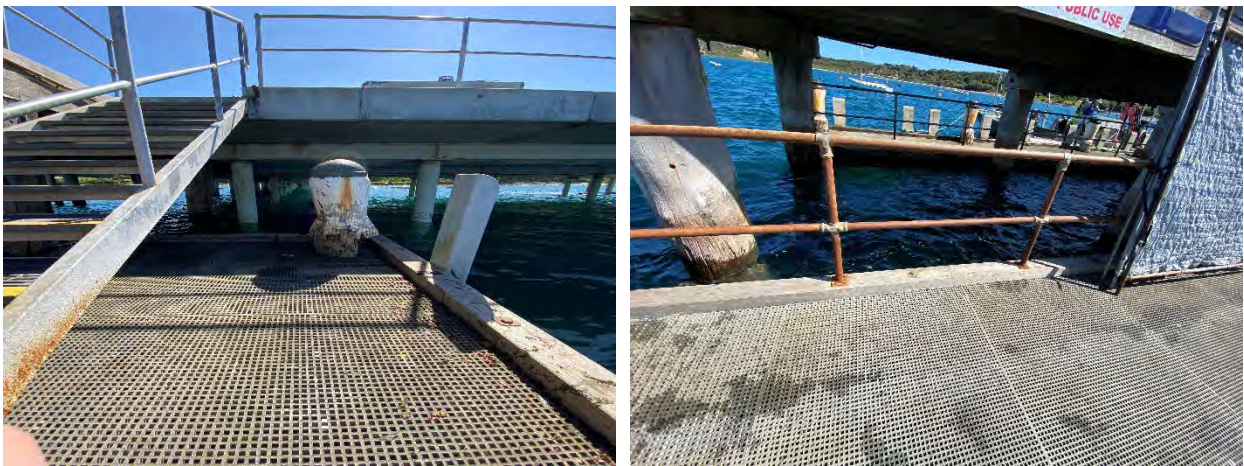
Figure 4-11: General condition of lower landing and barrier with corrosion

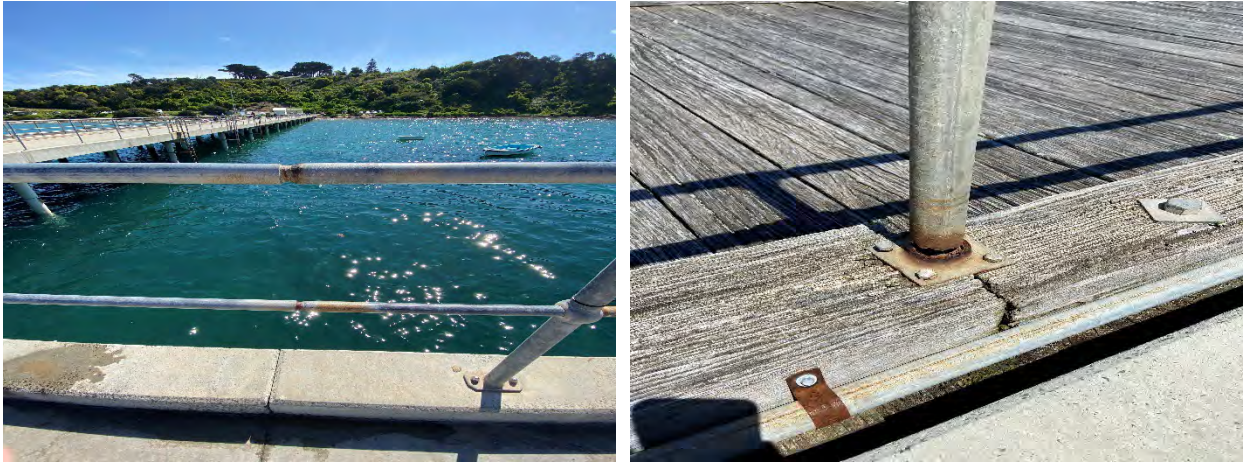
Figure 4-12 below highlights the general barrier conditions and demonstrates a local failure to the weld connection observed on the landside section of the timber pier, whilst Figure 4-13 shows inundation of the lower landing at high tide and the impact on the condition of the associated guardrail.

Figure 4-12: General condition of steel barrier (left) and localised failure at barrier connection (right)

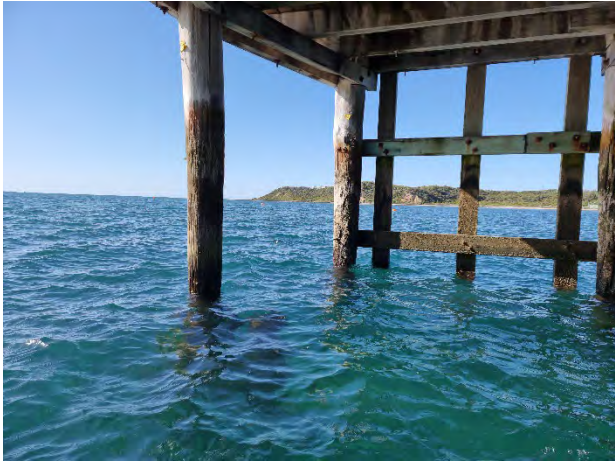
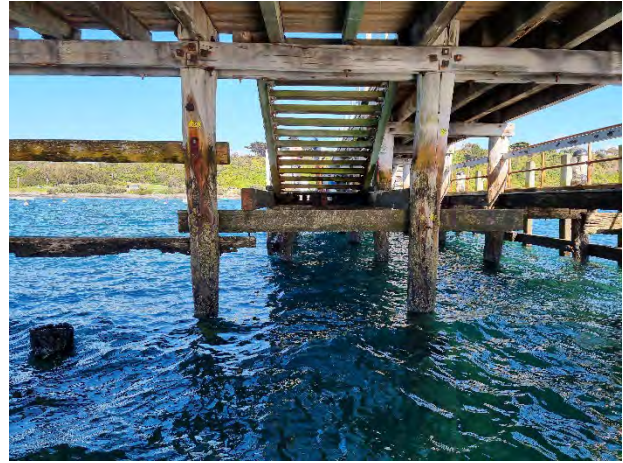
Figure 4-14: New timber walers and fenders at jetty head (left) and older members remaining (right)

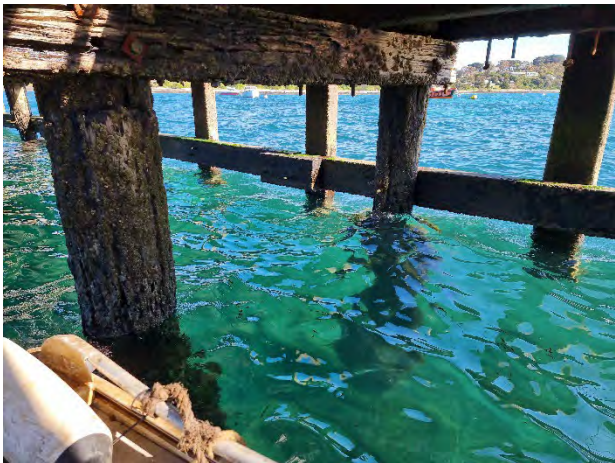
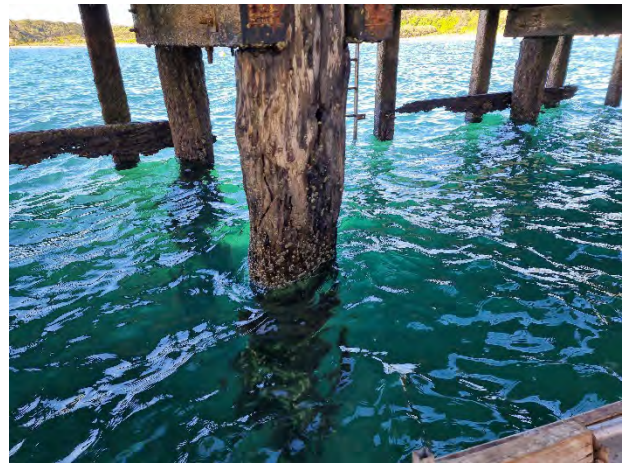
Timber fenders are installed to all lower landings and at the jetty head. In order to install the timber fenders, longitudinal timber members have been connected between piles at the lower landings. The timber fenders at the central lower landing (north and south) are in good condition as it appears they have recently been replaced. This is also the case for the northern lower landing at the jetty head. Only the south side landing fenders at the jetty head are in fair to poor condition (refer Figure 4-15).

Figure 4-15: New timber walers and fenders at jetty head lower landing (north) compared to old (south)

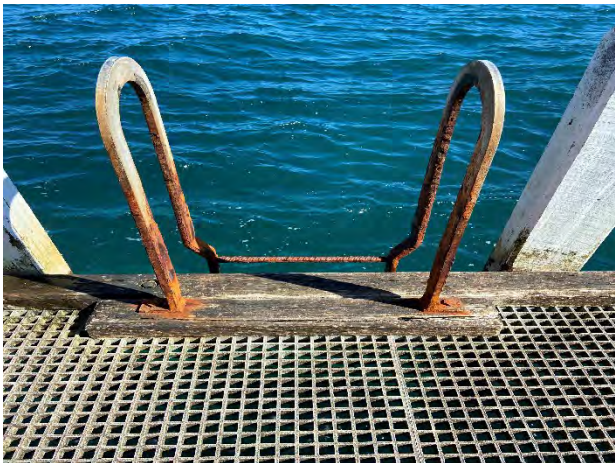
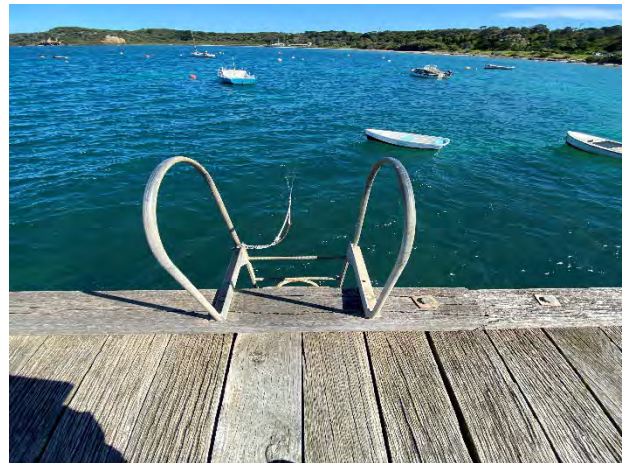
A number of steel and timber ladders have been installed along the length of the Timber Pier, atop the main jetty and also at lower landing levels. The condition of all the ladders ranged along their length and exposure to the tidal zone (refer Figure 4-16), however were still deemed serviceable.

Figure 4-16: General condition of ladders atop main jetty and installed to lower landing

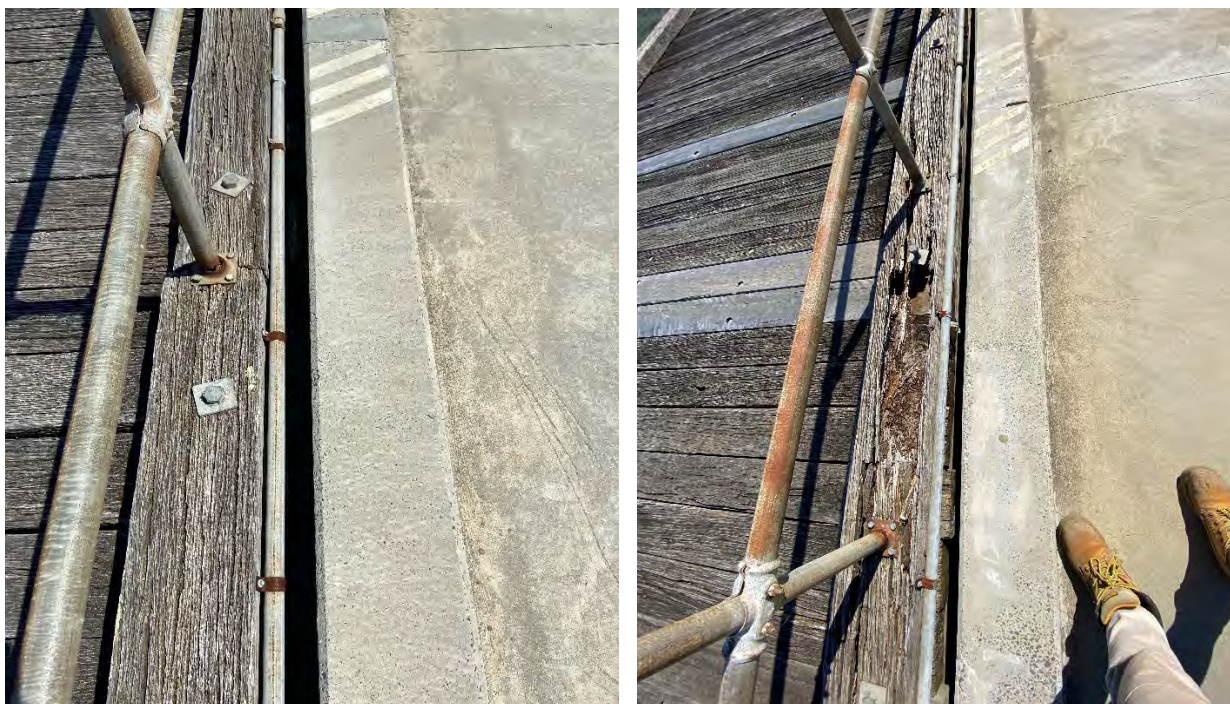
The condition of the timber capping beams that run along the length of the timber pier and act as kerbs ranged between Condition Rating 3 and Condition Rating 6 depending on location. Evidently, select members have been replaced over time due to localised degradation. Figure 4-17 outlines the typical condition of capping members and the most deteriorated member which was identified on the landside section of the Timber Pier.

Figure 4-17: General condition of timber capping (left) and localized damage (right)

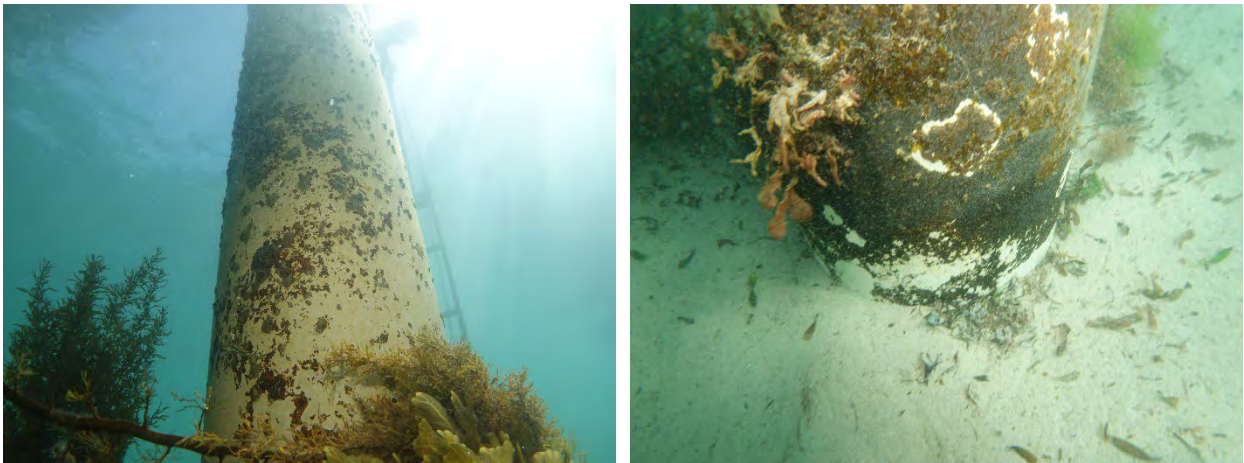
The piles were found to be in very good to good condition with all the piles assessed as Condition Rating 2 or 3. The piles were identified to be coated with a protective paint layer however noted that this coating was beginning to break down (as evidenced by scattered corrosion) affecting 70% of the piles. No evidence of accelerated low water corrosion (ALWC) was not observed. Refer Figure 4-18 and Figure 4-19 for a representation of the condition of the steel piles above and below-water.

Figure 4-18: General condition of steel piles below water

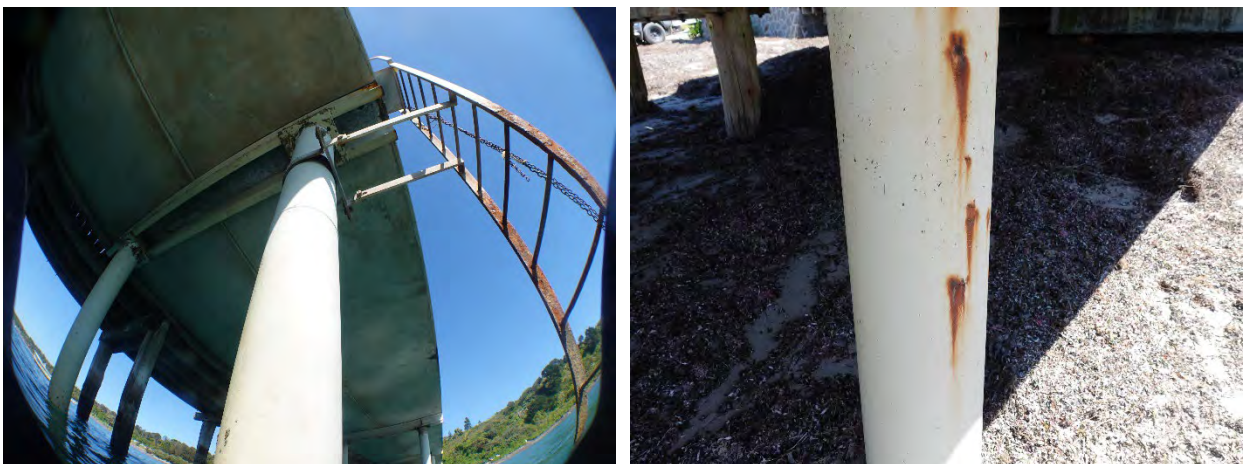
Figure 4-19: General condition of steel piles above water

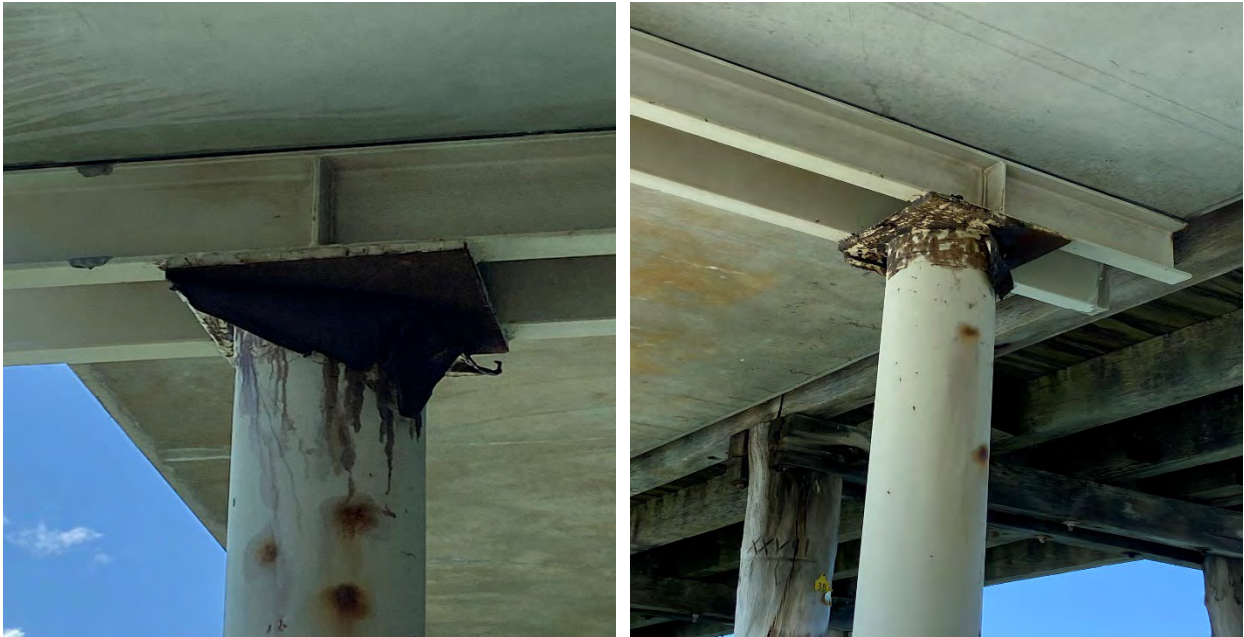
membrane was often peeling away from the surface of the steel allowing for top of the pile to develop surface rust to the exposed areas as shown in Figure 4-20.

Figure 4-20: Material noted at top of steel piles and base plate location

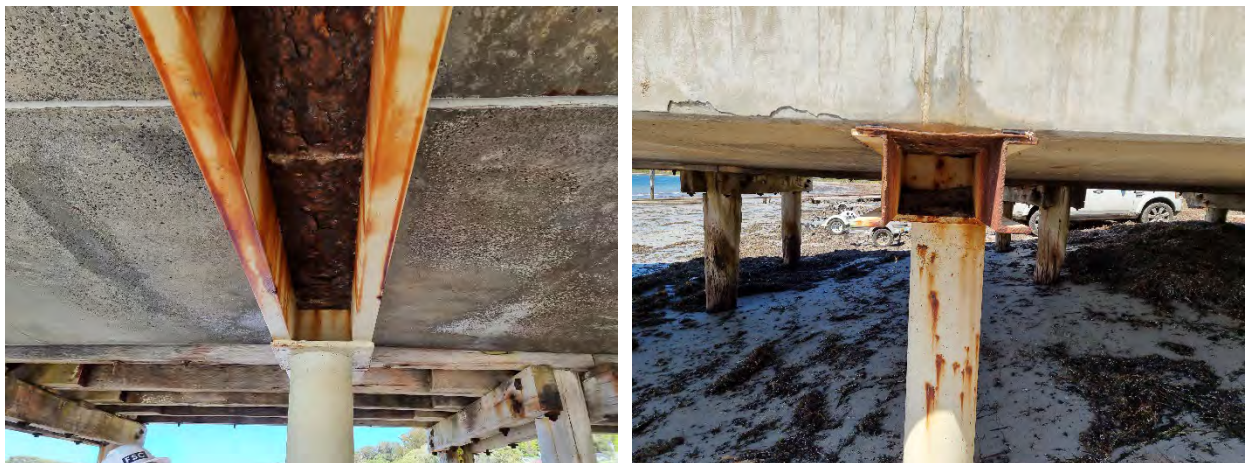
Figure 4-21: Rust staining of crossheads from plate above

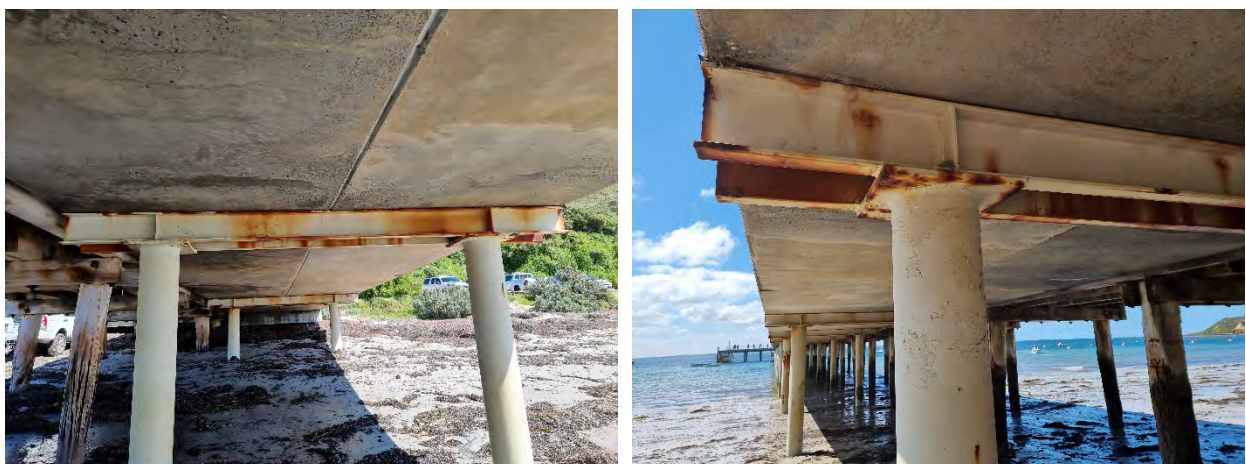
It is unclear if the top plate is intended to contribute to the structural capacity of the crosshead and upon review of the construction drawings the plate detail cannot be found. However, if left untreated, the corrosion is likely to extend (if not already) to the PFC members causing progressive deterioration of the crossheads. Many of the PFCs are currently stained with rust product from the plate above which will typically lead to an advanced rate of coating degradation. Refer Figure 4-21 and Figure 4-22 for a typical PFC configuration and rust staining.

Figure 4-22: General condition of steel crossheads

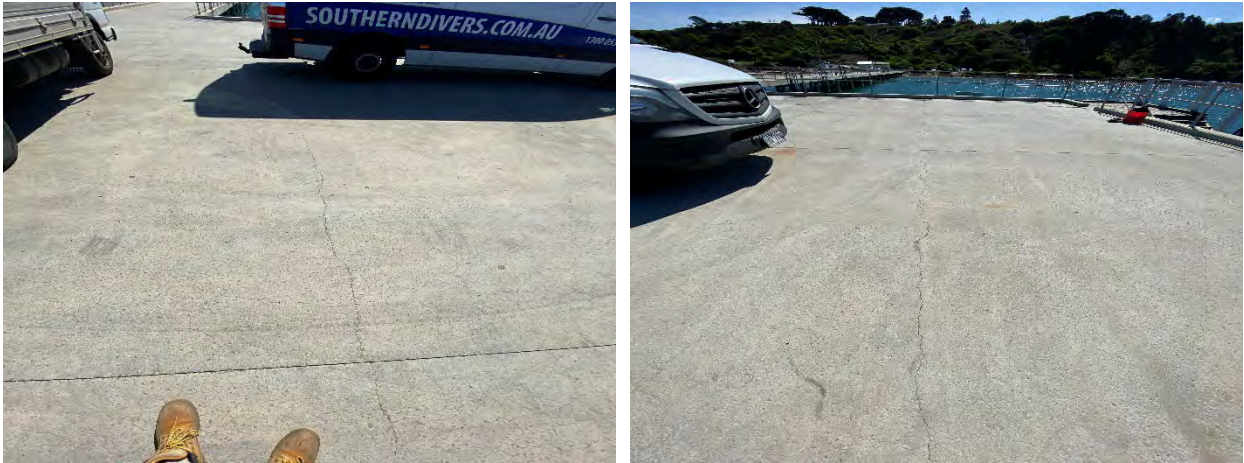
The concrete deck was generally in very good condition and assessed as Condition Rating 2, however at the jetty head turning bay, numerous longitudinal cracks in the topping slab were found to propagate the full length of the jetty head and hence were assessed as Condition Rating 4. These cracks were found to coincide with the longitudinal joints between the underlying precast deck elements and is likely due to shrinkage of the insitu topping slab or differential movement from thermal expansion and contraction over the larger footprint as compared to the narrower approach.

Figure 4-23: Longitudinal cracking in turning bay

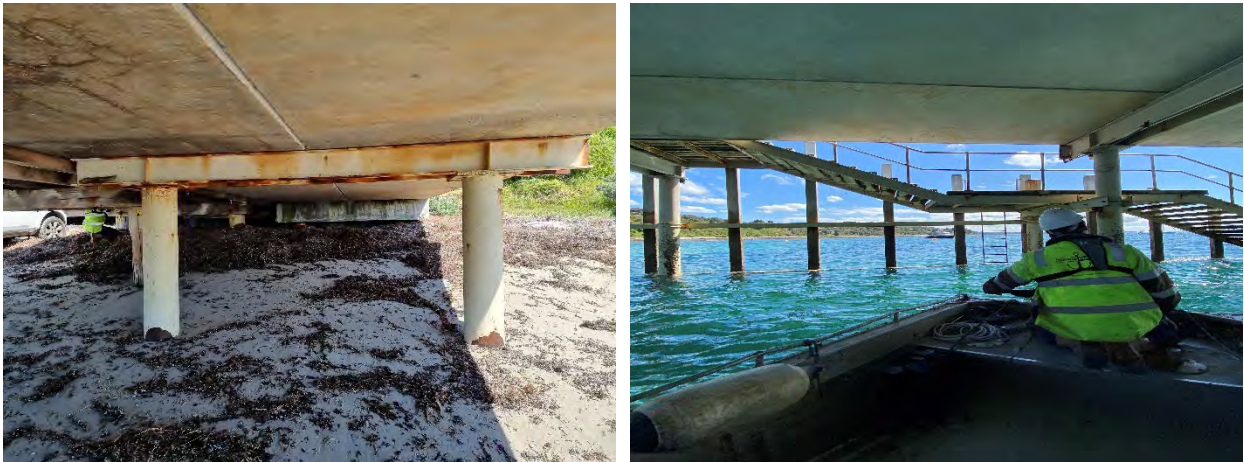
The concrete deck soffit was also in very good condition (refer Figure 4-24).

Figure 4-24: General condition of concrete deck soffit

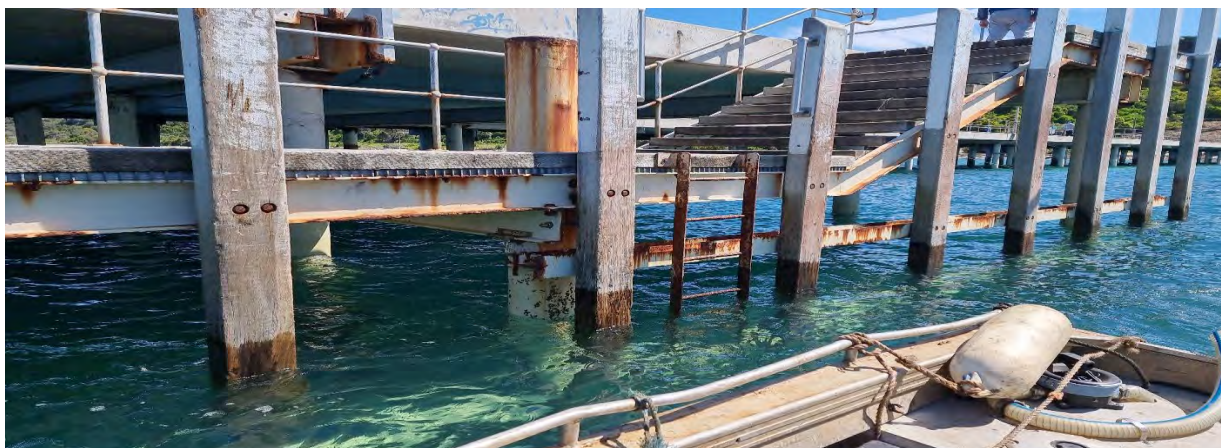
design practice because as this area becomes inundated during high tide events, water pools within the channel of the UC and is not adequately draining through the drainage holes provided (often these will become blocked and require ongoing maintenance). The water held within these channels has already lead to onset of corrosion (refer Figure 4-26). The steel beams that support the FRP was also beginning to corrode.

Figure 4-26: UC waler member collecting water and onset of corrosion

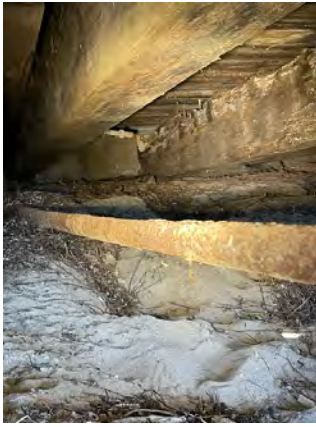
Damage to stringers attached to land

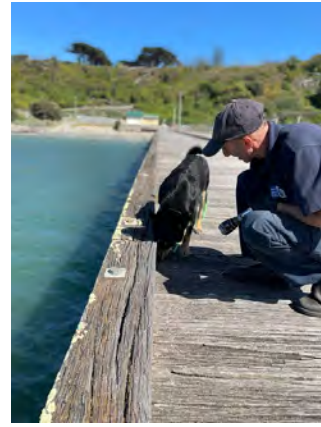
Sniffer dog detected activity around 20-23c capping

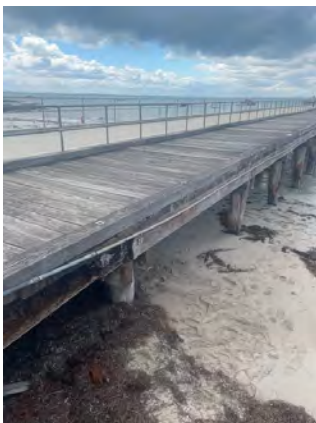
Decay and marine borers
