Condition Assessment Report

Flinders Pier
Parks Victoria

Reference 210178
Revision 4
Date 4 May 2022

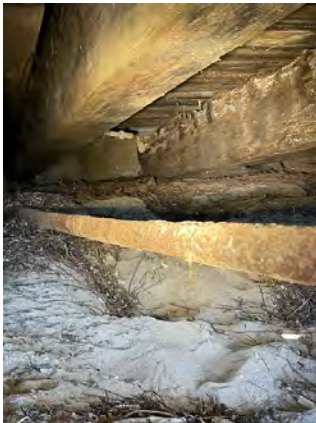
Ground contact of pier
