Condition Assessment Report

Flinders Pier
Parks Victoria

Reference 210178
Revision 4
Date 4 May 2022

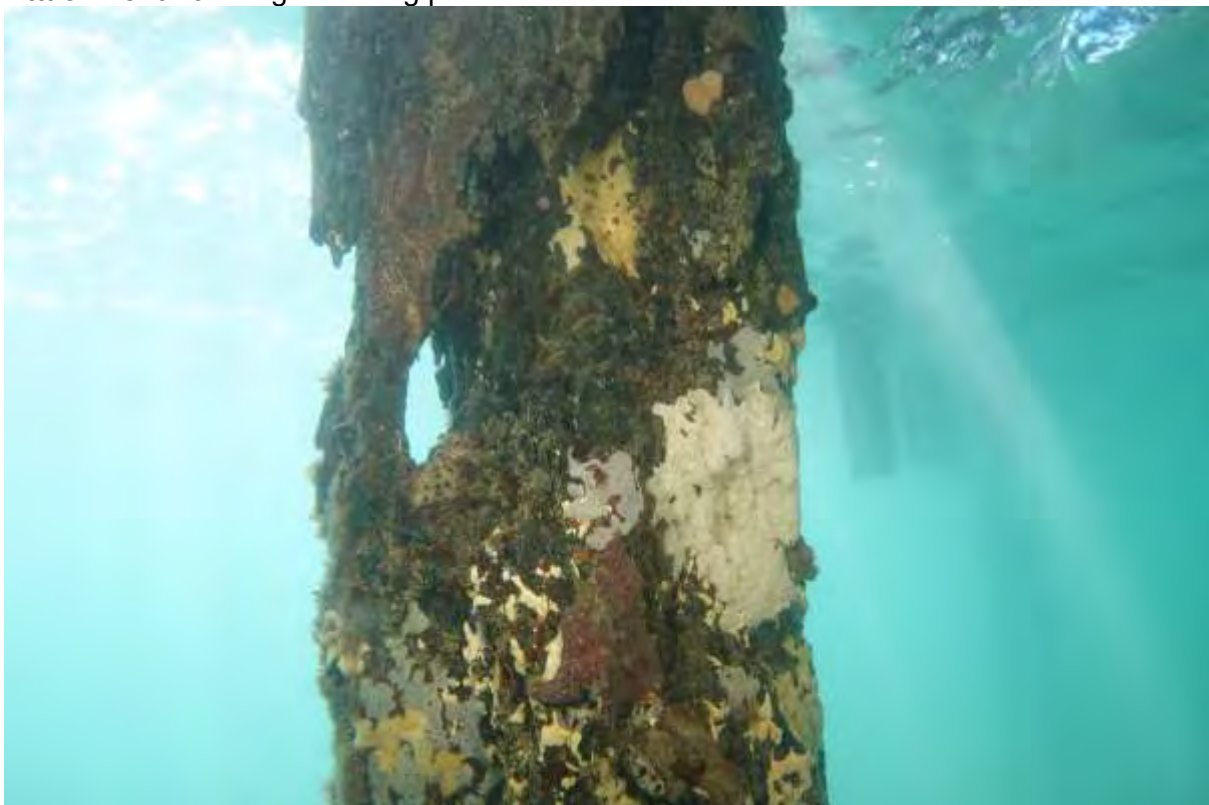
Attachment 13. Image showing pile 44A

Figure 4-3: Localised cavity in Pile 44A (Condition 6 - left) and sound condition at seabed level (right)

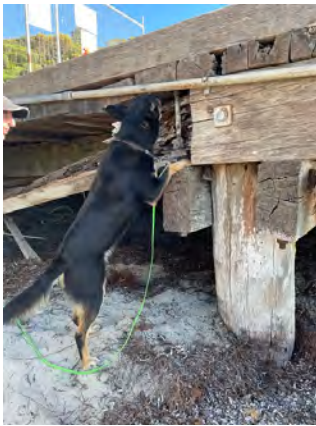
Sniffer dog detected activity around 20-23c capping

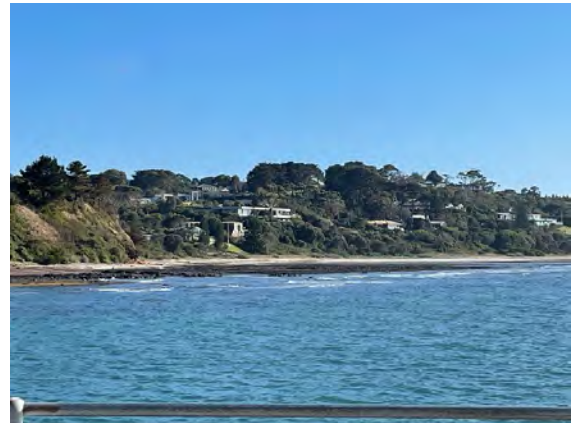
Trees and ocean environment
